ST MARY THE VIRGIN
CRATFIELD
SUFFOLK

CHURCH GUIDE

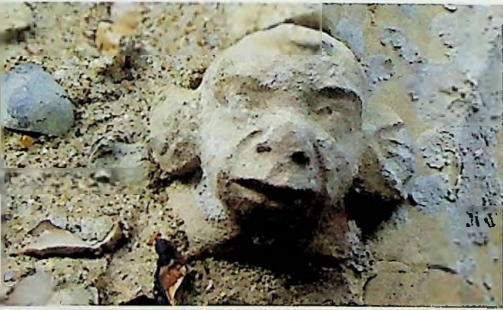
One of the charming carved headstaps on the aisle windows where the masons have indulged themselves with caricatures, perhaps of local worthies, the vicar or the church wardens?

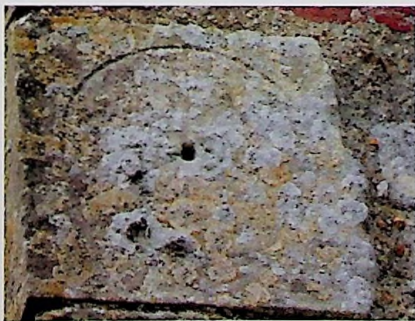
One of the Mass dials.

Walking east from the porch, you can just make out the **mass dials** on the upper stages of the next two buttresses. They are at a most unusual height and would have been quite inaccessible to anyone wanting to use them which suggests they may have been moved at a later date.

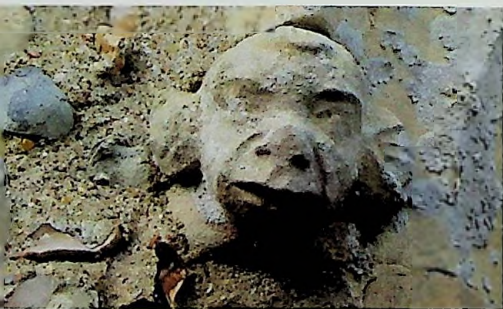
One of the charming carved headstops on the aisle windows where the masons have indulged themselves with caricatures, perhaps of local worthies, the vicar or the church wardens?

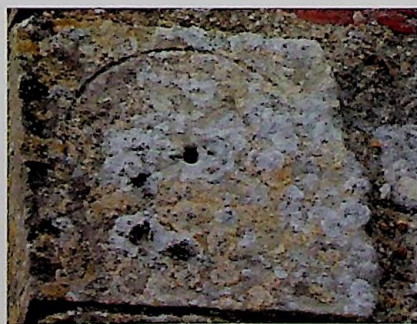
One of the Mass dials.

Walking east from the porch, you can just make out the **mass dials** on the upper stages of the next two buttresses. They are at a most unusual height and would have been quite inaccessible to anyone wanting to use them which suggests they may have been moved at a later date.

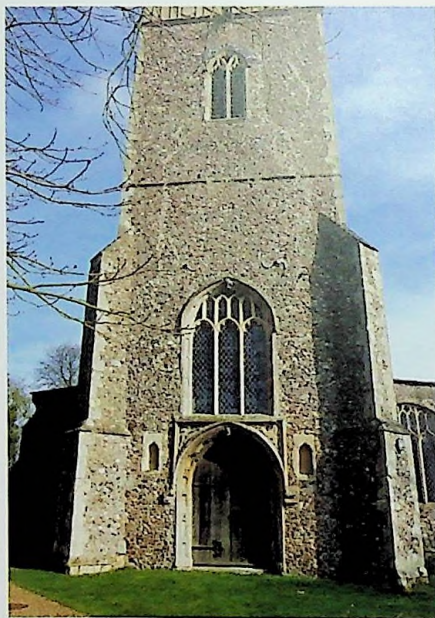
The West door.

preserved carvings of a woodwose, a wild or green man, and the dragon he is fighting with his club and shield. There was a belief that this represented the struggle between mankind in a state of innocence battling with the temptations of the devil. There is an angel at the apex of the door arch to offer help from above and guardian lion stops to the hood mould. Above the door is the west window which has at the top of the arch a beautifully preserved, bearded figure of a man at prayer, perhaps a benefactor, and lions' head stops to the bottom of the hood mould. Less well preserved are the niches on either side of the doorway which would have contained statues of saints, possibly St Edmund, the 9th century king of East Anglia, and St Thomas of Canterbury, the two saints to whom the chantry altars were dedicated. There are none of the frivolities in this ensemble which the masons permitted themselves around the south aisle windows.

In the mouldings around this great door are crowns and the emblems of the Virgin Mary, an M surmounted with a crown. The door itself is a Victorian replacement. In the spandrels are unusually well-

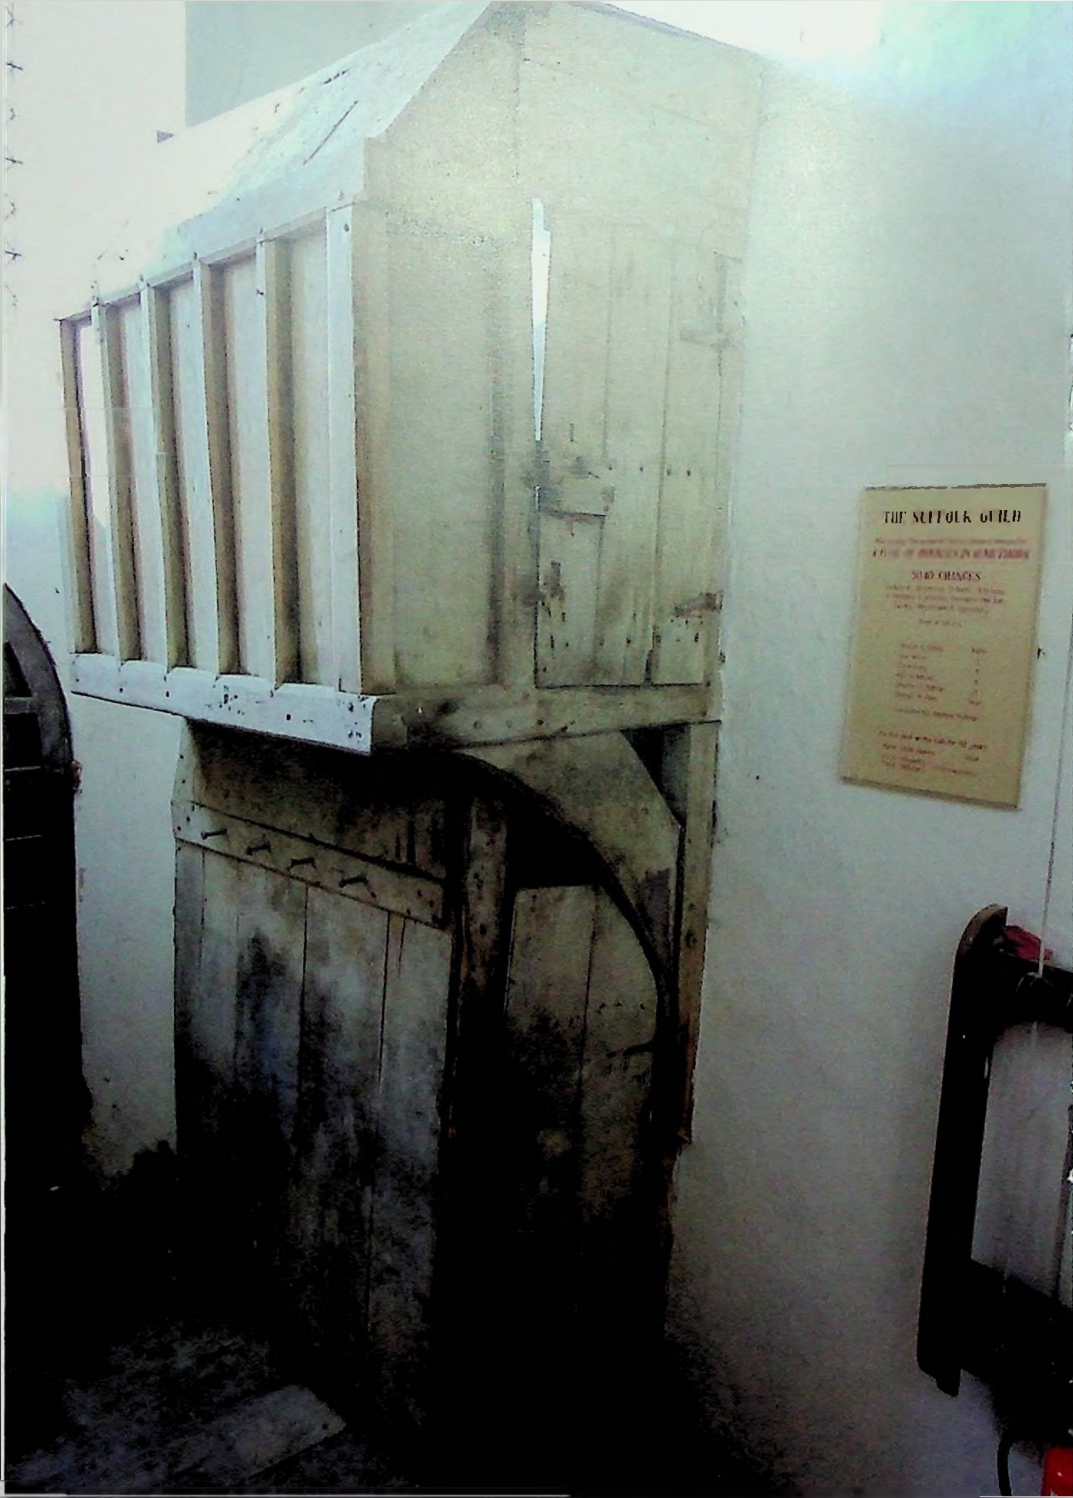
In the bottom of the tower is a rare treasure, always known as the **clock case**, but which has recently been identified as of much greater significance. It is built out of oak and consists of a raised platform with a panelled balustrade surround and two large, curved, supporting wall brackets. A later, rather crude cupboard has been built below it which was not part of the original structure.

The medieval organ gallery with the roof and cupboard that were added later when it became a clock case.

After examining all the evidence the archaeologists concluded that our 'clock case', the construction of which pre-dates the first mention of a clock by fifty years, was the **medieval organ gallery**, or organ perke, built to house the organ that was acquired in 1497. Medieval organs were much smaller than modern instruments and would have fitted happily within this gallery.

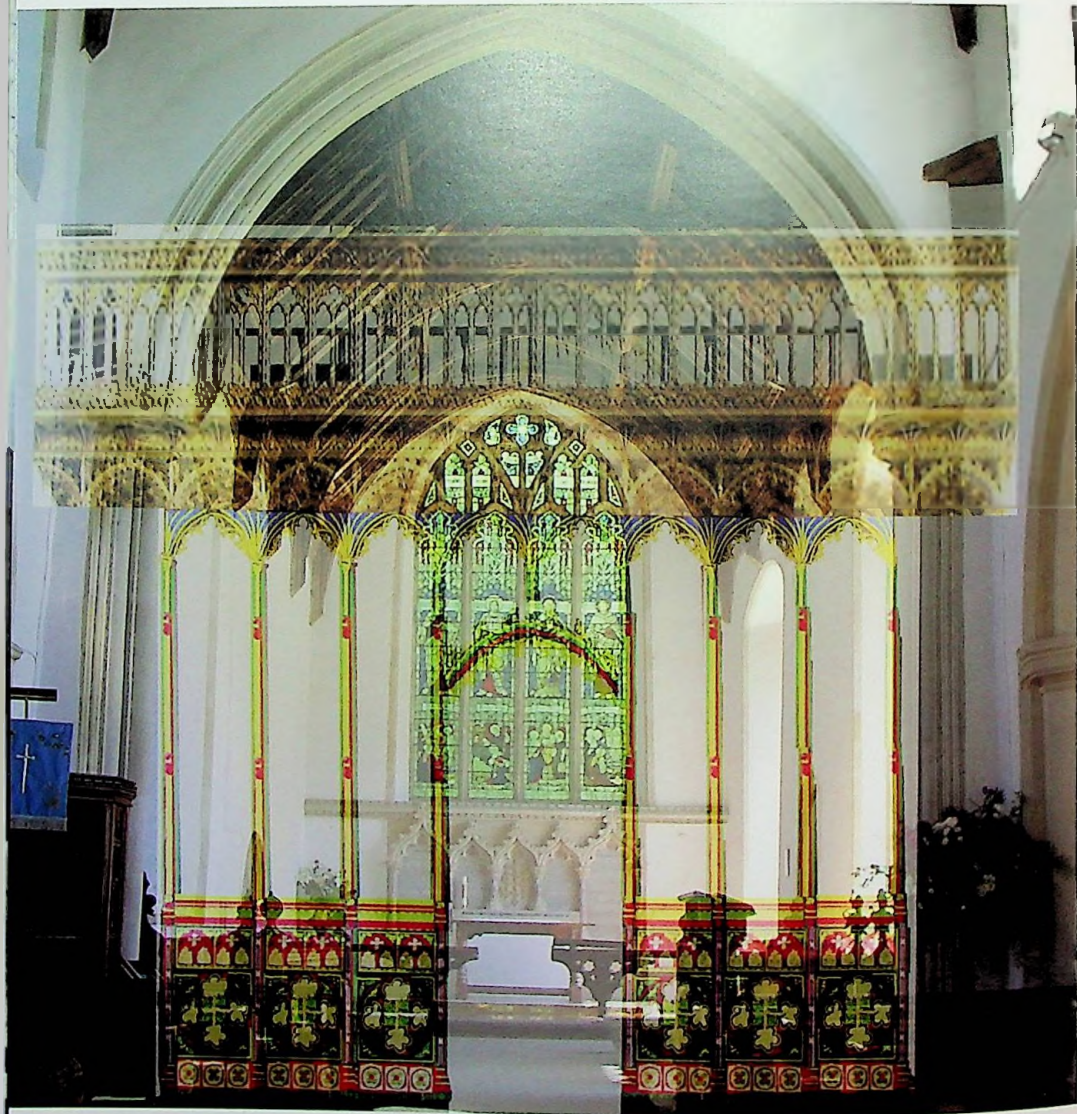
A computer image by Tim Howson of how the chancel screen might have looked after the removal of the Rood and statues.

Cratfield screen is a rather battered relic, showing all the scars of just such a chequered history. In 1832, when David Elisha Davy visited Cratfield for the second time, it was still relatively complete and in position in the chancel arch, missing only its loft and statues. However, by 1875 only the bottom half remained while the upper part had been sawn off, shortened and placed in the musicians' gallery at the west end. During the Victorian restorations the separated fragments of the screen were roughly reassembled and it spent the next stage of its life standing against the wall at

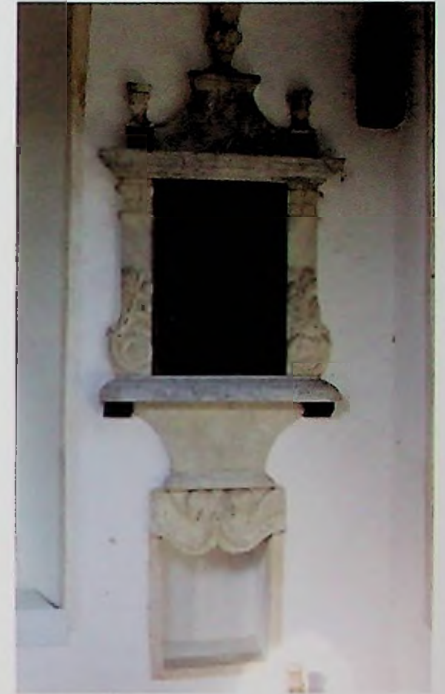
Sarah Mynne's memorial over the chantry chapel aumbry.

At the east end of the north aisle the position of one of those altars can clearly be seen. There is a recess in the north wall that was originally the aumbry, the cupboard for storing the sacred vessels, which has been rather charmingly adopted by two cherubs as part of Sarah Mynne's memorial of 1724, perhaps adding a little extra sanctity for Mrs Mynne in the process. Opposite this is the piscina where the chalice was rinsed after the Mass. Above that is the stone bracket on which would have stood the figure of the saint to whom the altar was dedicated.

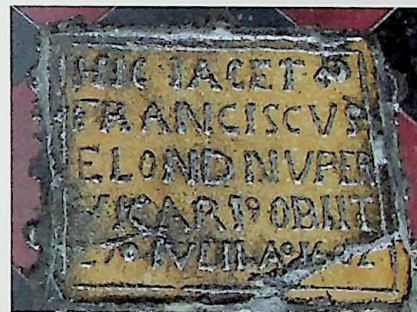
Francis Eland's memorial tablet.

Probably the most characteristically Victorian work was the replacement of the old flooring pammments and ledger slabs with Mintons encaustic tiles. The memorial slabs were moved to the west end behind the font but for some reason an exception was made for Francis Eland's little tablet which was allowed to remain

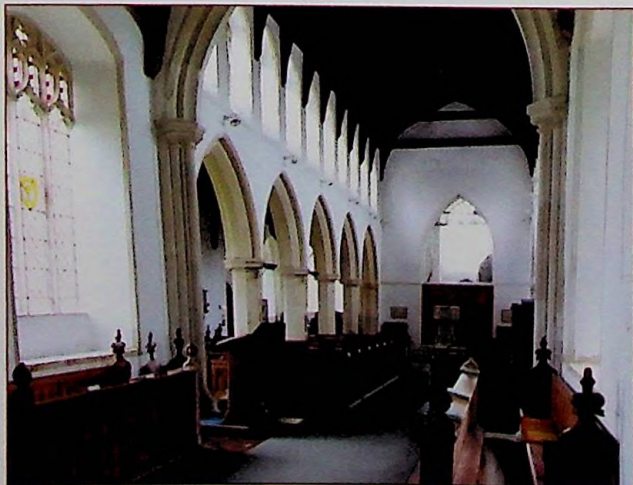
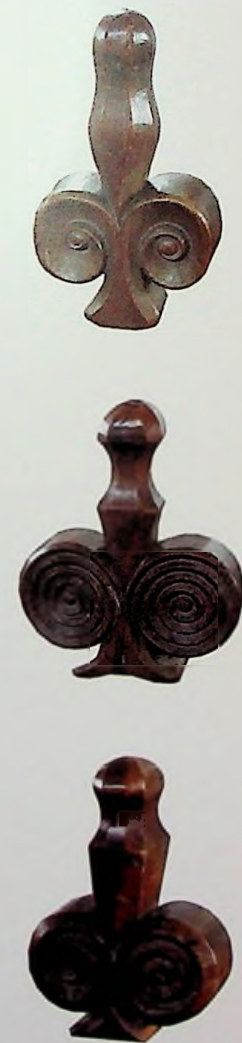
17th century poppy-head finials.

View of the West end and 15th century century pew ends in the chancel.

The **pews** in the aisles are 17th century originals with delightfully varied, rustic

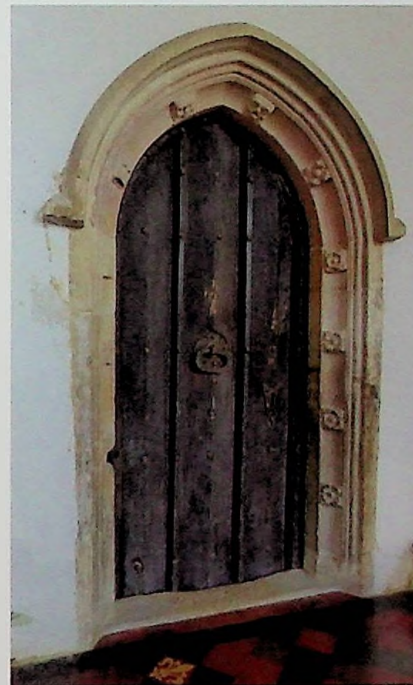
Vestry door.

In the north wall of the chancel is the entrance to the vestry with its original oak door and stone surround decorated with fleurons, a crown and two heads, probably 1400s.

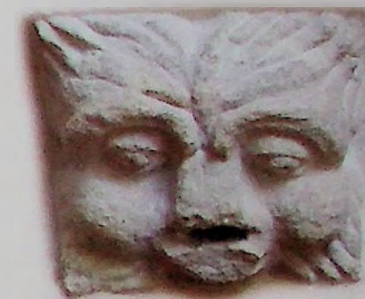
A detail around the vestry door.
